Report of Radiological Survey of Beverly Hills High
School and Venoco Oil Well Site

California Department of Health Services,
Radiologic Health Branch

Revised November 2003

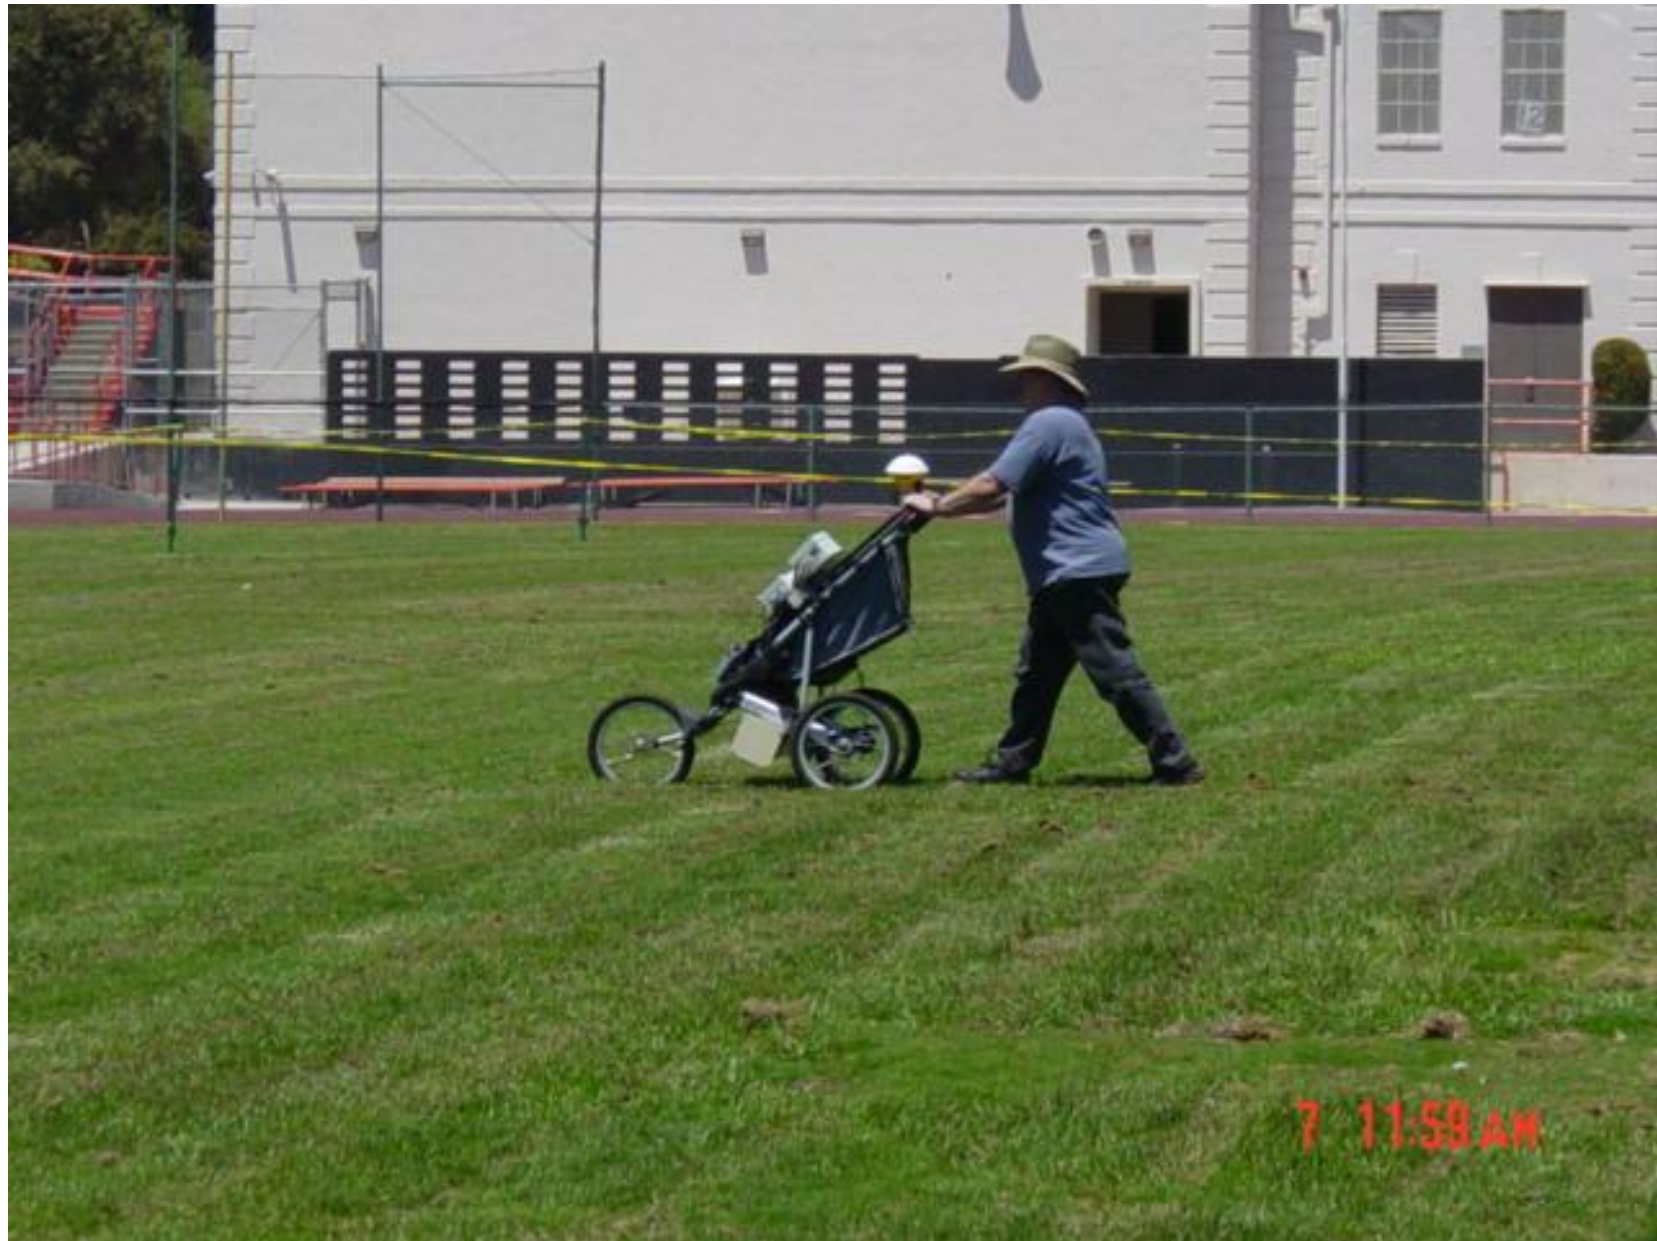
Figure 2: Radiation Data Logging System on Track Field

- A radiation mapping survey of 25% of all the areas accessible to the “buggy” at the Venoco oil well site (approximately 50% of the Venoco site was accessible to the “buggy”), BHHS softball field, outdoor basketball courts, and athletic field (Figure 2.) The radiation data logging system recorded 13,381 data points with each data point

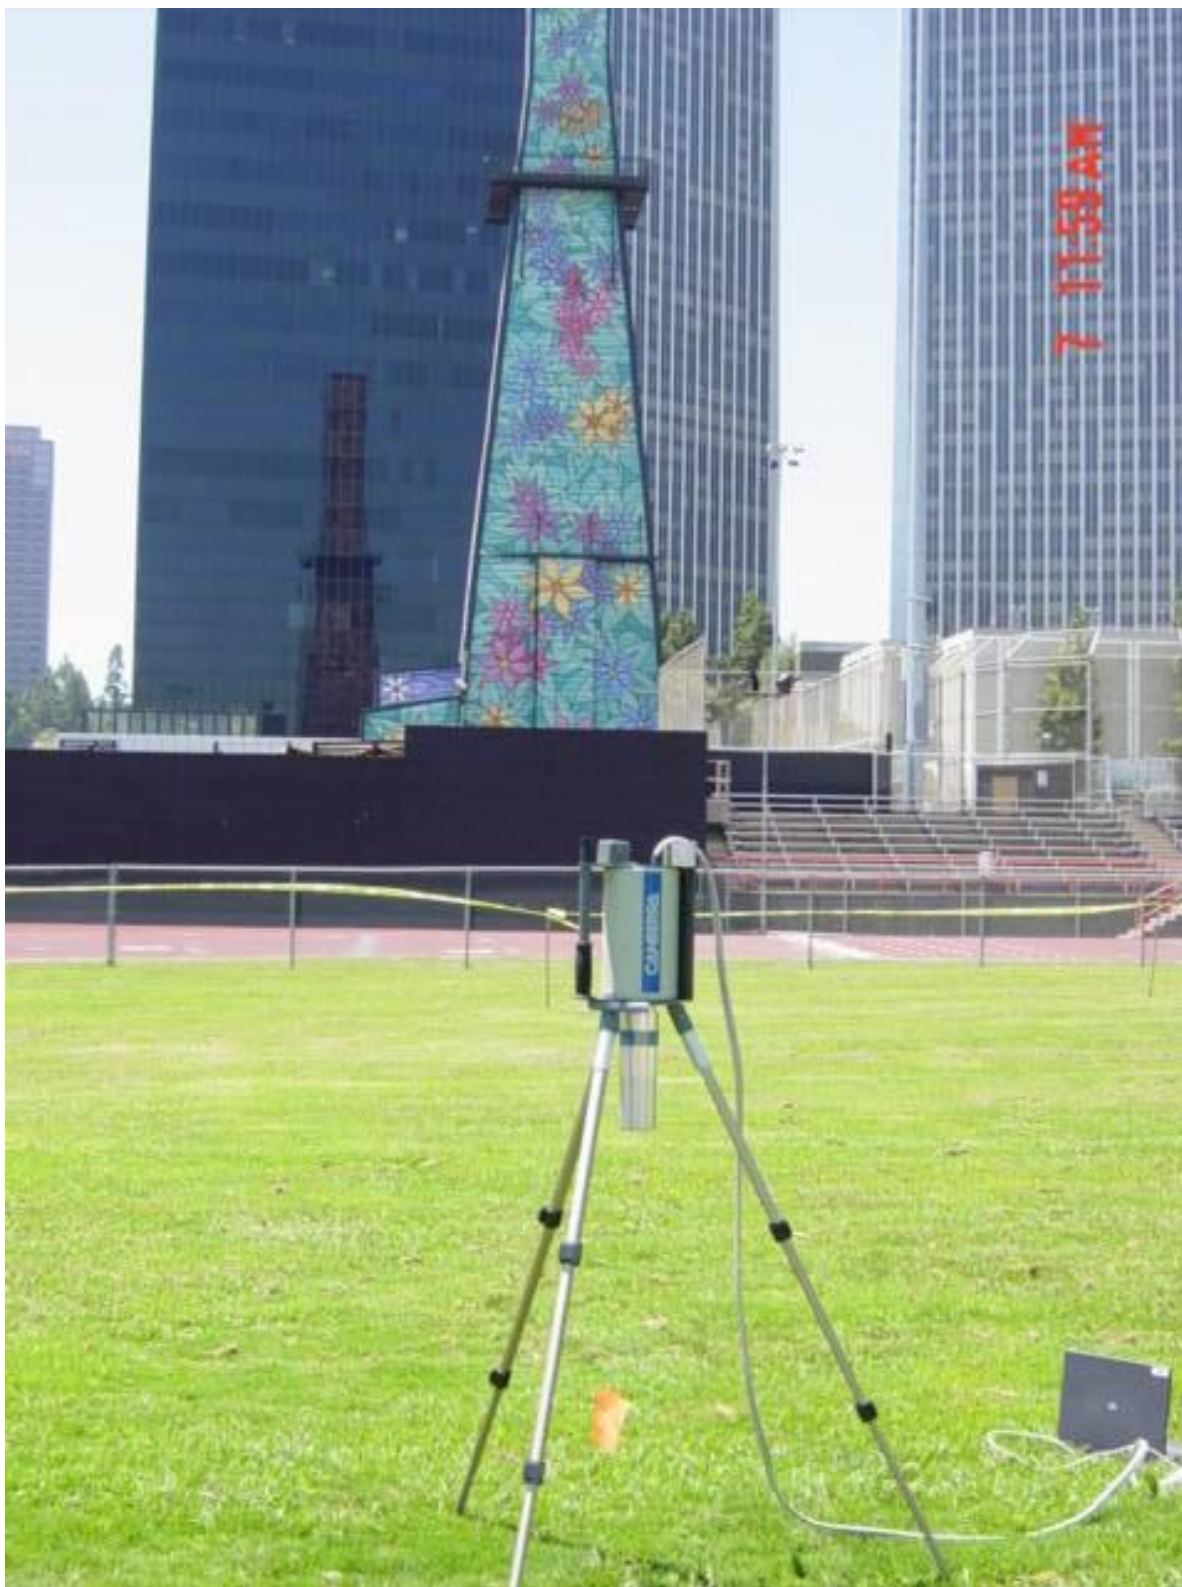
- Eight in-situ HPGe detector gamma spectroscopy measurements and seven discreet soil samples were collected at BHHS. No soil samples were obtained in the outdoor basketball court because it was paved. See Figures 4 & 5 and Tables 1 through 3. As an example of HPGe measurement, see Figure 6.
- In-situ HPGe measurements were obtained at biased locations on the Venoco site (well head area, Figure 7) and at random locations at the site (Figure 8). In-situ HPGe measurements showed only naturally occurring radioactive materials consistent with normal background, see Table 1. No I-131 was identified during this survey.

Figure 6: High Purity Germanium Detector In-Situ Measurement on Track Field

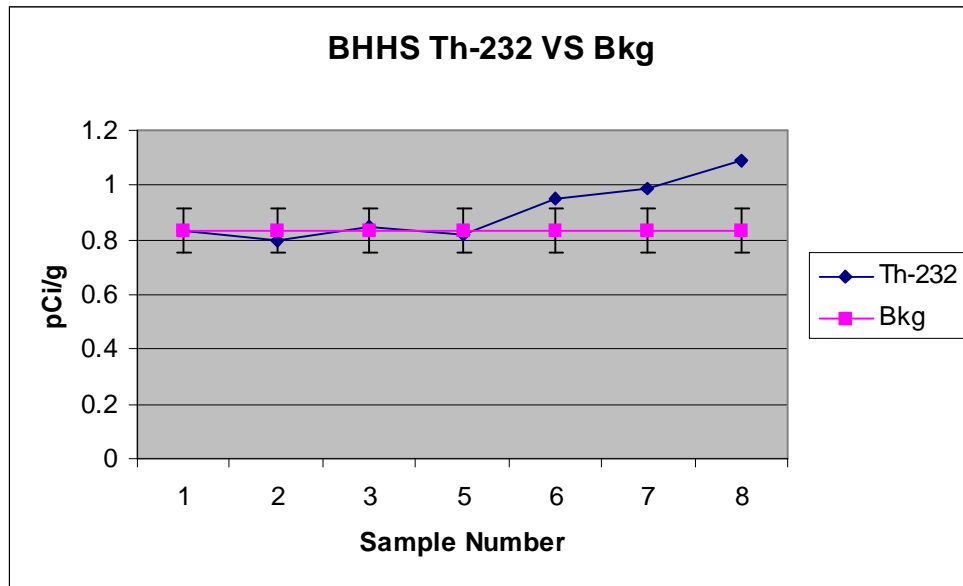
concentration been significantly higher than that of U-238, then there would have been a strong possibility that the Venoco site could be a source of NORM contamination. But since this was not found to be the case, the Venoco site is not a source of NORM contamination. Several comparison graphs of the laboratory alpha spectroscopic analysis results of the soil samples are depicted in Figures 11, 12 and 13. Figure 14 shows a comparison of the U-238 alpha spectroscopic analysis results to the Ra-226 gamma spectroscopic analysis results. In addition, see Table 1 for all spectroscopic analysis results used in these graphs.

Figure 13: Comparison of Th-232 from BHHS and Th-232 from background
